Alaskan Way Viaduct **REPLACEMENT** PROGRAM

Seattle City Council
Jan. 12, 2015

SR 99 tunnel contract

OVERVIEW

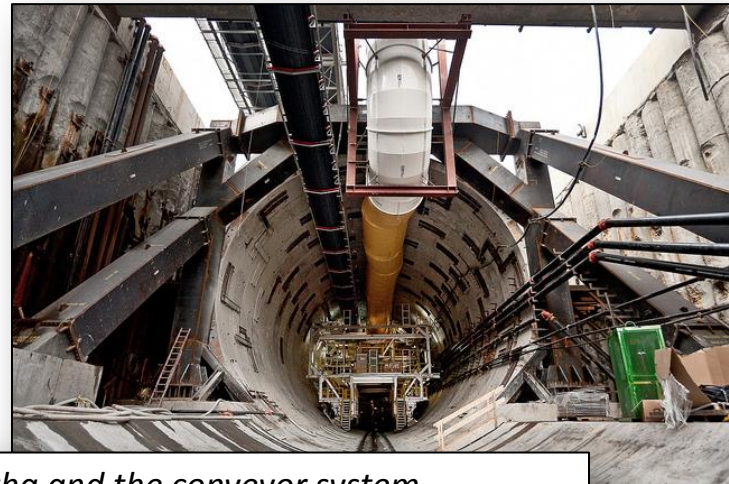
- Conveyor system
- Manufacture, transport, assembly and support for the tunneling machine
- Muck storage facility

Bertha and the conveyor system.

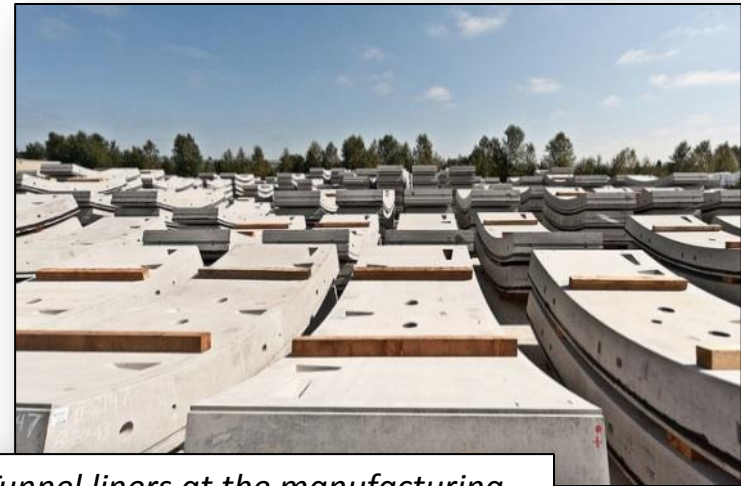
Tunnel liners at the manufacturing facility in Frederickson, Wash.

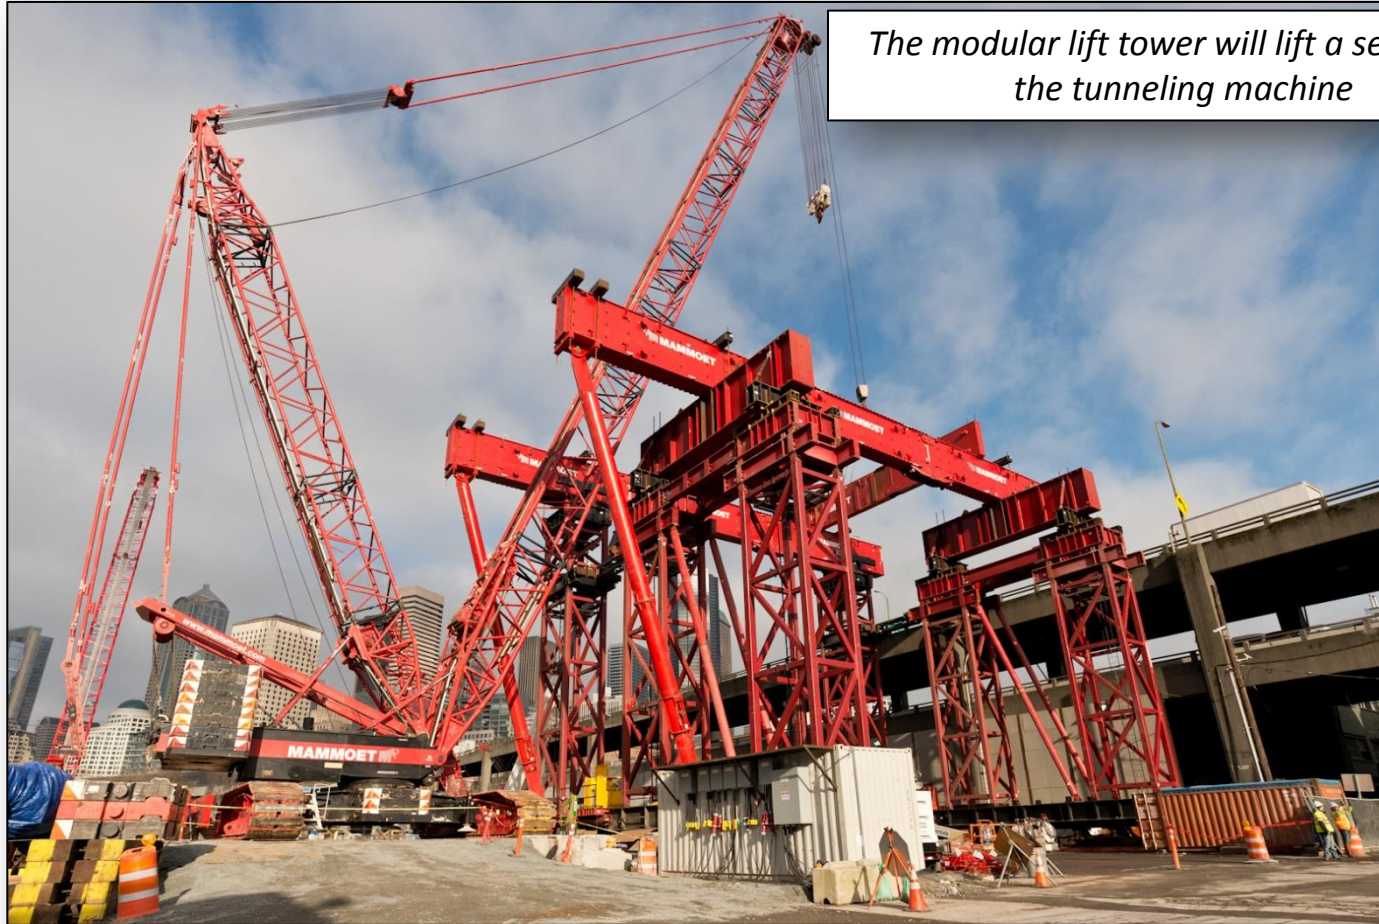
The modular lift tower will lift a section of the tunneling machine

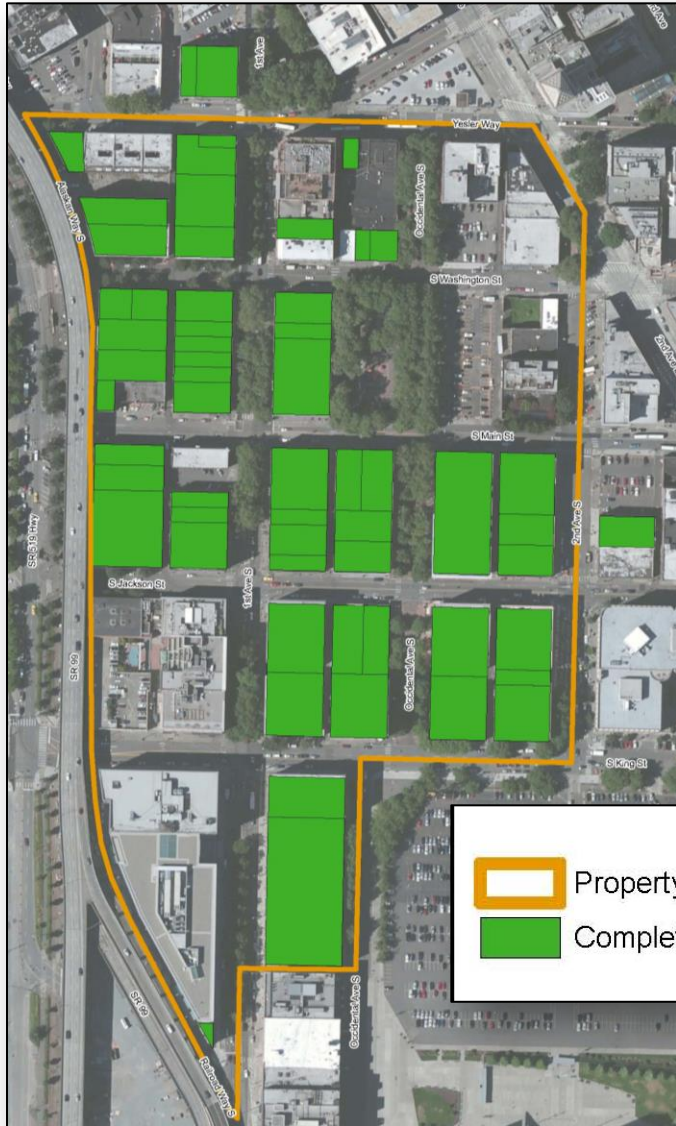
- Completed more than 55 building assessments. No structural damage.
- Coordinating with property owners on property condition surveys.

Property Owner Coordination Area

Completed Visual Building Assessments
